CITY OF NAPERVILLE

**BID NUMBER: REQ-22-114 WORK
ORDER #4**

ENGINEERING SERVICES FOR CENTRAL ELEVATED WATER TANK RELOCATION

On July 23, 2021, Dixon Engineering Inc. performed a preliminary maintenance inspection on the 500,000 gallon radial arm (Central Tank) elevated water storage tank owned by the City of Naperville, Illinois. Purposes of the inspection were to evaluate the interior and exterior coating's performance and life expectancy, assess the condition of metal surfaces and appurtenances, review safety and health aspects, and make budgetary recommendations for continued maintenance of the tank. All recommendations with budgeting estimates for repairs are incorporated in this report.

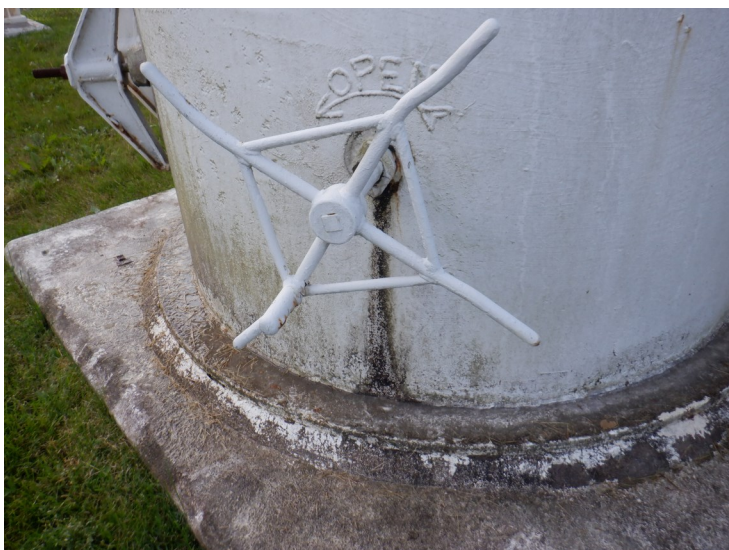
3) The riser drain valve is not functional.

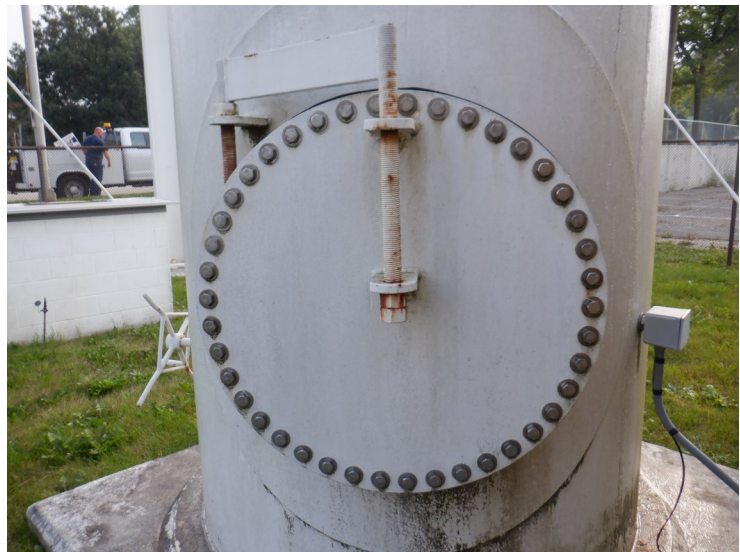
4) The elliptical riser manway is in good condition.

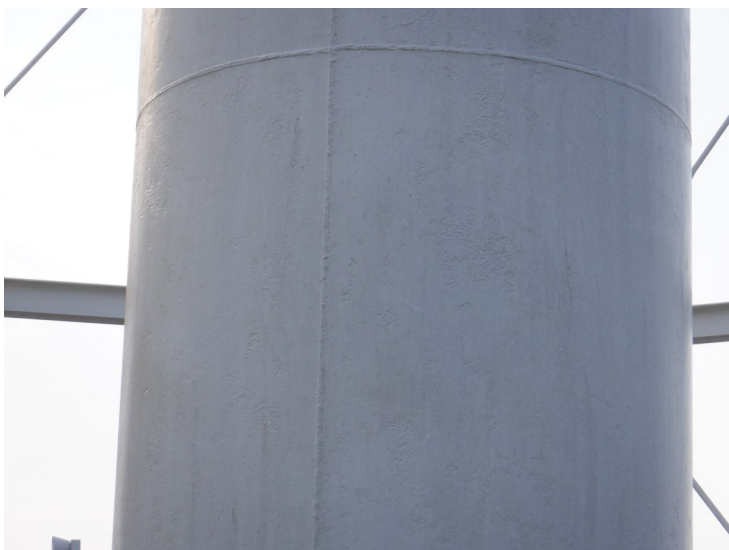
5) The bolted riser manway is in good condition.

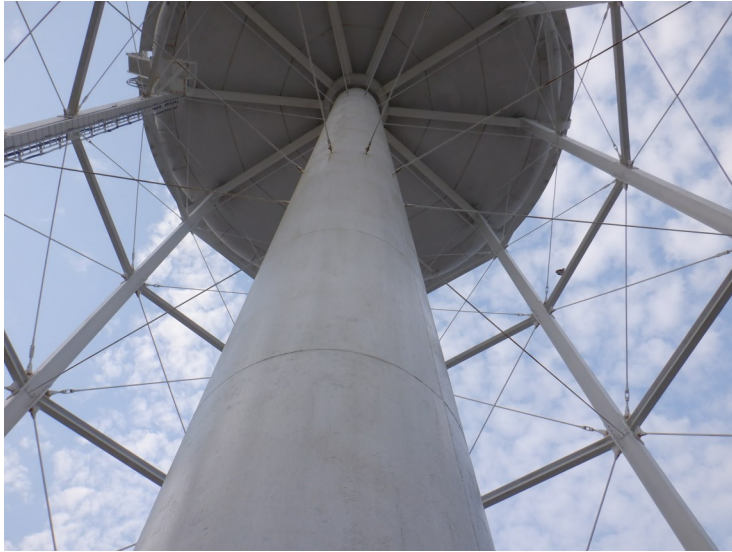
The riser and leg coating is in fair condition with numerous failures. Primary methods of deterioration are spot failures to the substrate with rust undercutting, rust bleedthrough, and micro-cracking.

6) The riser coating is in fair condition overall.

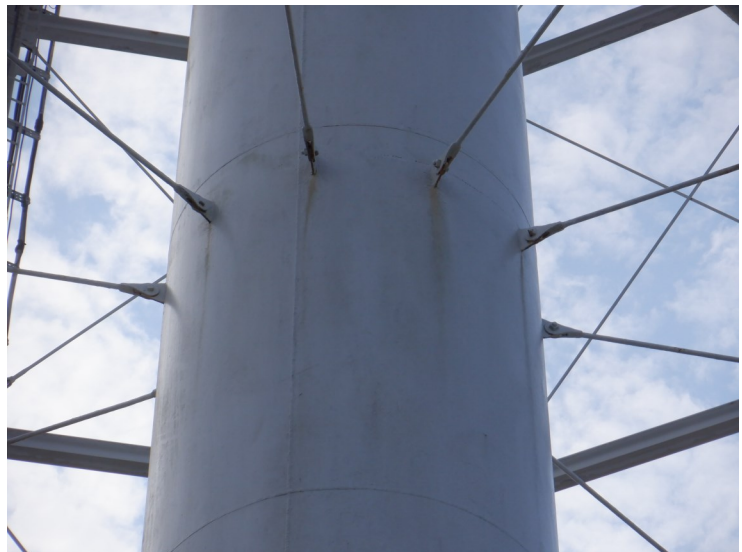
7) Same.

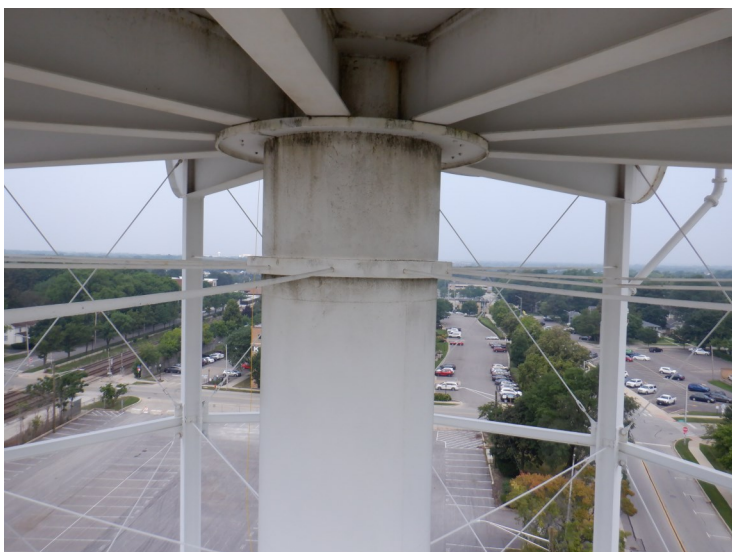
8) The riser tie rods are attached to welded lugs that are in good condition.

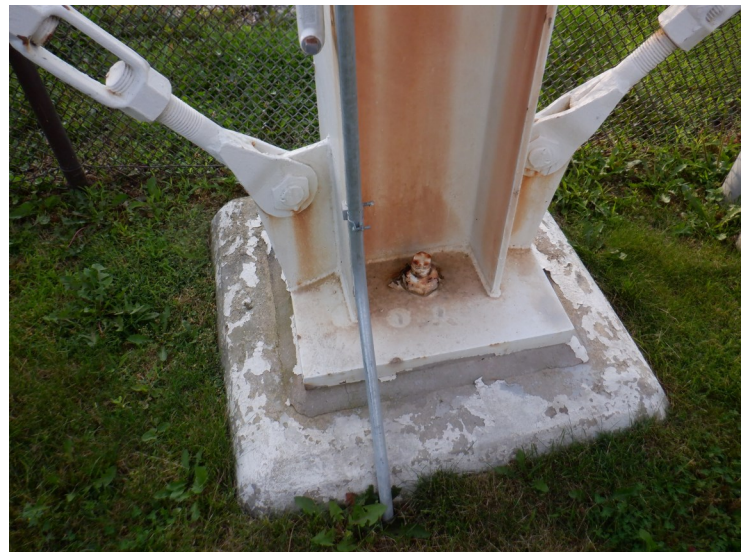
10) Typical leg foundation that is in good condition. The coating is in poor condition overall.

7. Recoat the foundations to help prevent deterioration. The cost would be incidental to exterior painting.
8. Replace the deteriorated anchor bolt nuts. The cost would be incidental to the next paint project.

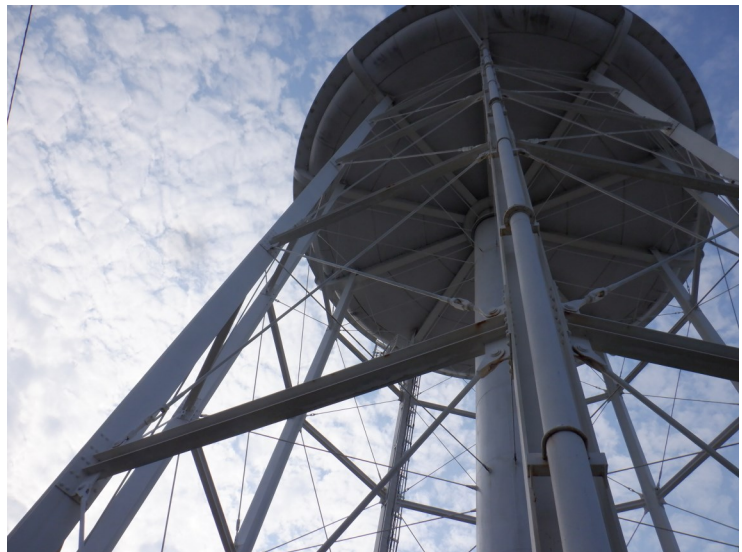
16) Coating failures with rust undercutting on a leg.

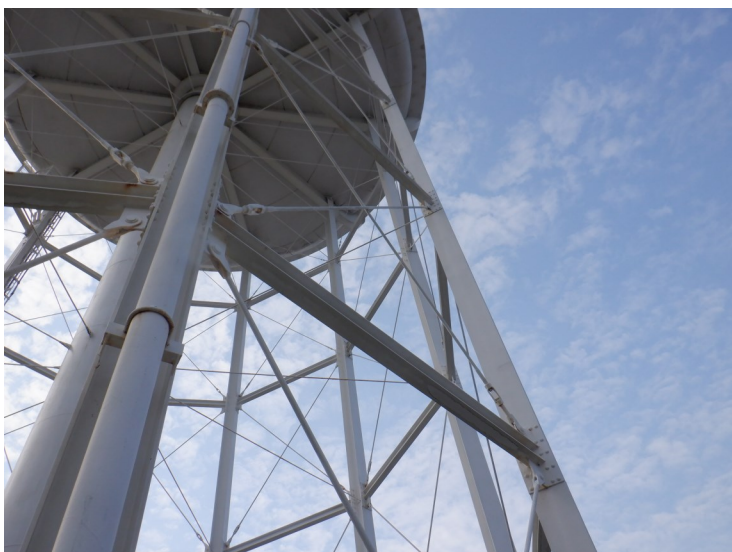
17) The leg coating is in fair condition overall.

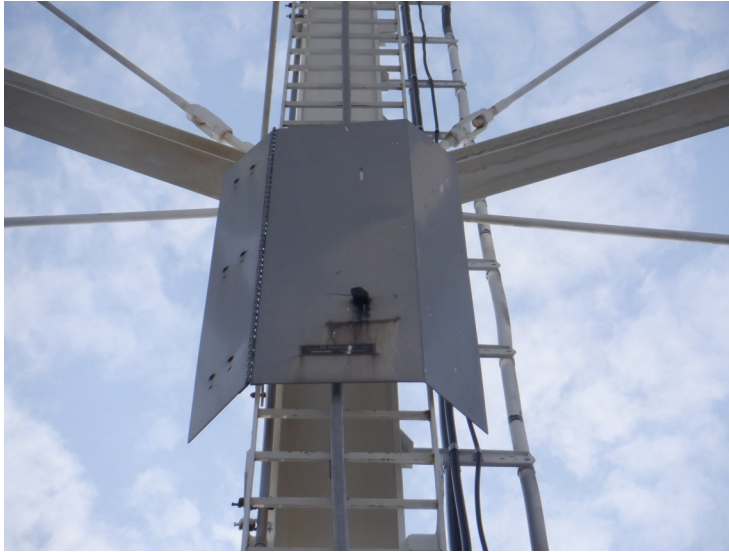
18) Same.

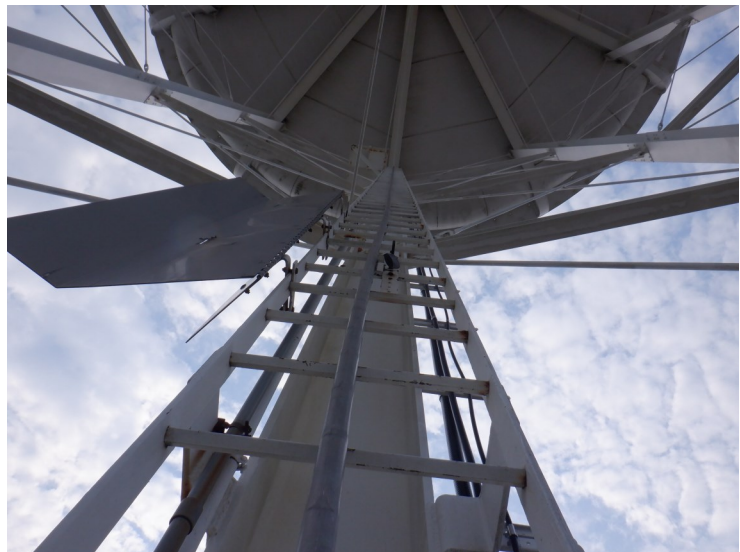
19) The leg ladder is equipped with a vandal guard that is in good condition.

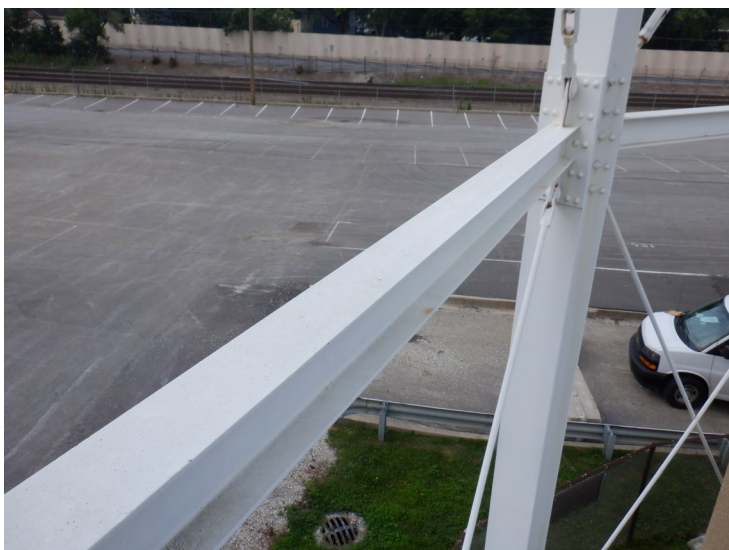
20) The ladder is in good condition. The ladder is equipped with a fall prevention device.

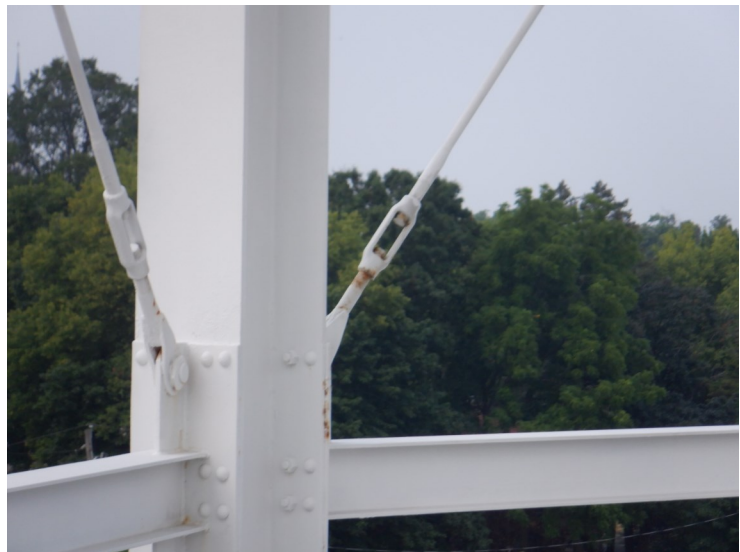
22) Spot coating failures and rust bleedthrough at a strut and leg connection.

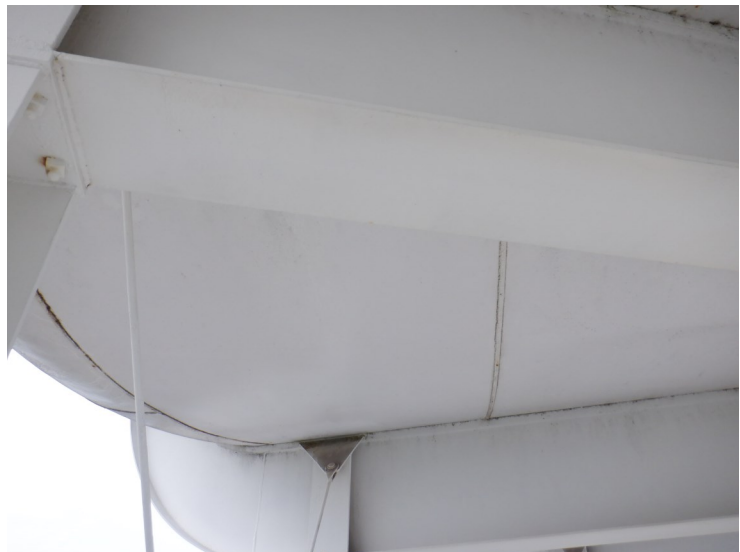
The bowl coating is in fair condition with several failures. Primary methods of deterioration are spot failures to the substrate with rust undercutting. The bowl is covered with light to moderate mildew growth.

25) The bowl coating is in fair condition overall. There is mildew growth on the bowl.

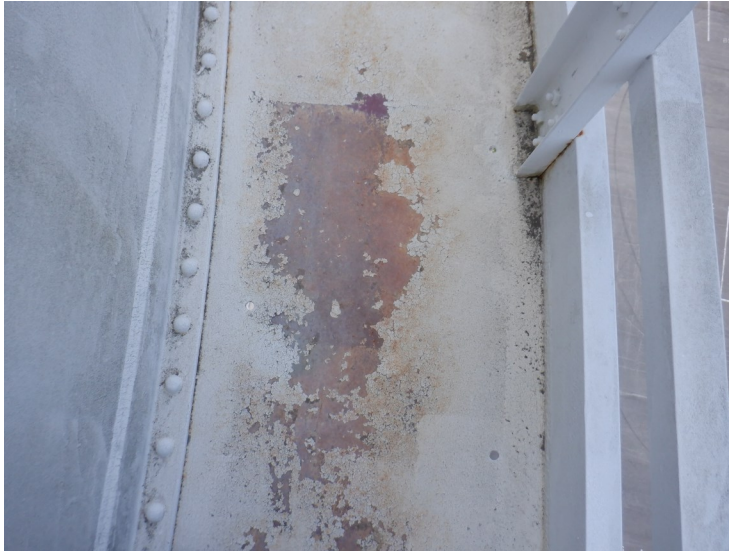
Coating on the top of the balcony is in poor condition with numerous failures. Primary methods of deterioration are spot failures to the substrate with rust undercutting, rust bleedthrough, delaminated topcoat, and erosion.

30) The balcony is in good condition. The coating is in poor condition.

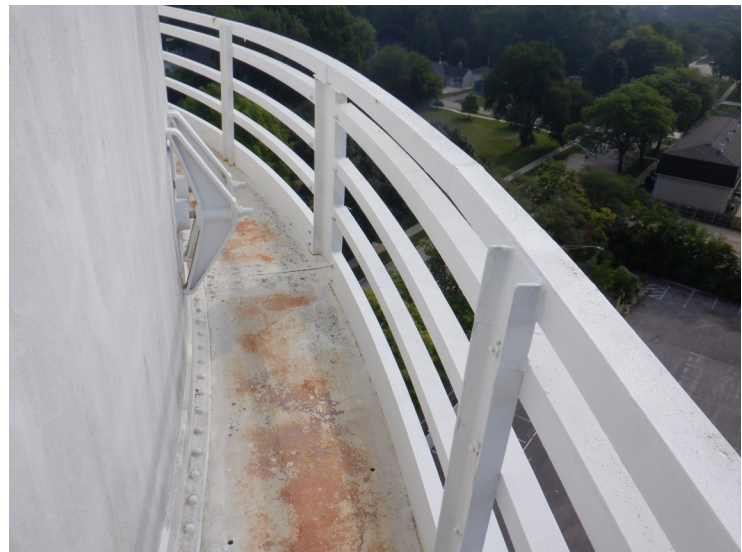
31) Same.

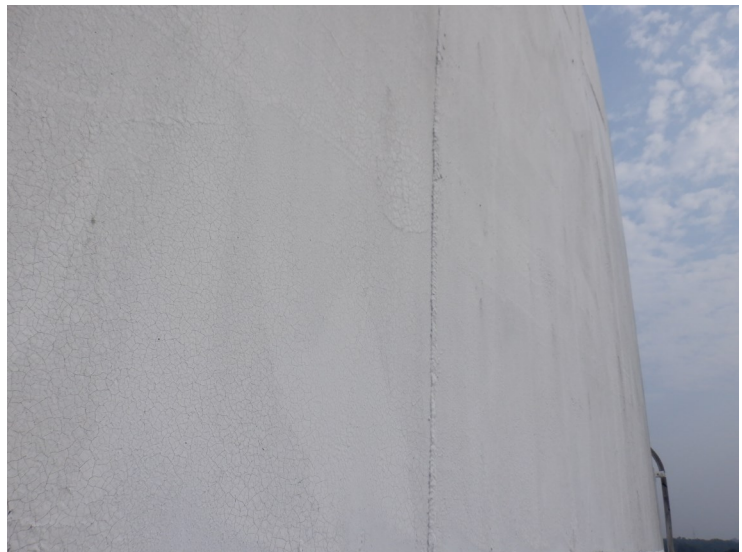
34) The sidewall manway is in good condition.

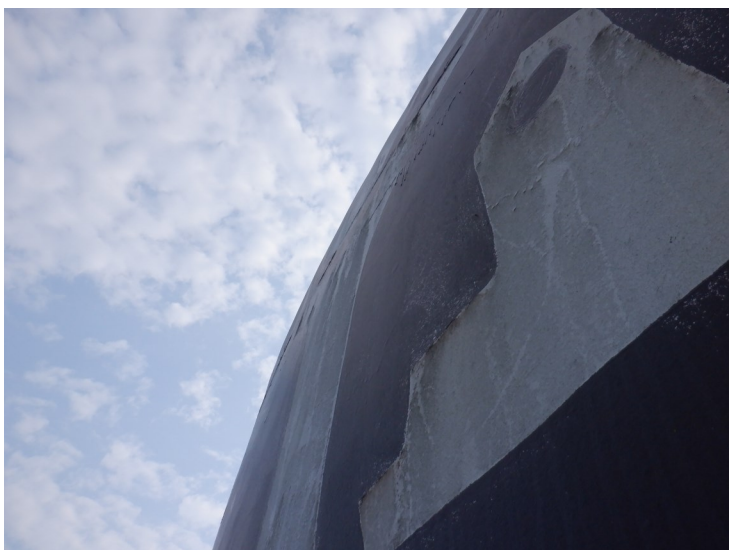
The sidewall coating is in fair to poor condition with numerous failures on the sidewall. Primary method of deterioration is micro-cracking. There is lettering that states "NAPERVILLE" on the sidewall in one location. There is a city logo on the sidewall in one location.

35) The sidewall coating is in fair condition overall.

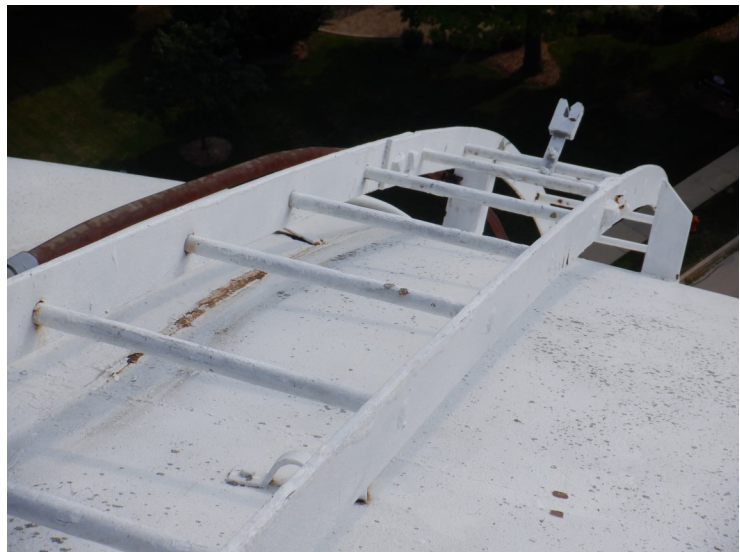
37) The sidewall ladder is in good condition. The ladder is not equipped with a fall prevention device.

15. Install a handrail where one is missing at the step-off platform under the bowl. The estimated cost is \$2,000.
16. Replace the sidewall/roof ladder with a vertical ladder and a step-off platform. The estimated cost is \$15,000.

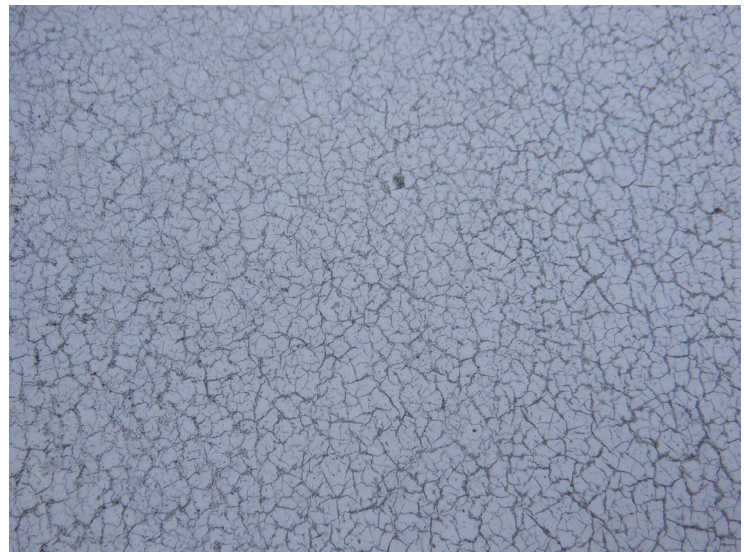
The roof coating is in poor condition with numerous failures. Primary methods of deterioration are spot failures to the substrate with rust undercutting, delaminated topcoat, erosion, and micro-cracking.

46) The roof coating is in poor condition overall.

Budget for total exterior coating removal and repainting in approximately one to two years or when aesthetics dictate. Fading will continue and more rust spots will occur decreasing the tank's aesthetic appearance.

Remove the existing coating by dry abrasive blast cleaning the steel to a commercial (SSPC-SP6) condition and apply a urethane system. All blast work would be performed inside a dust tight containment system using negative air pressure.

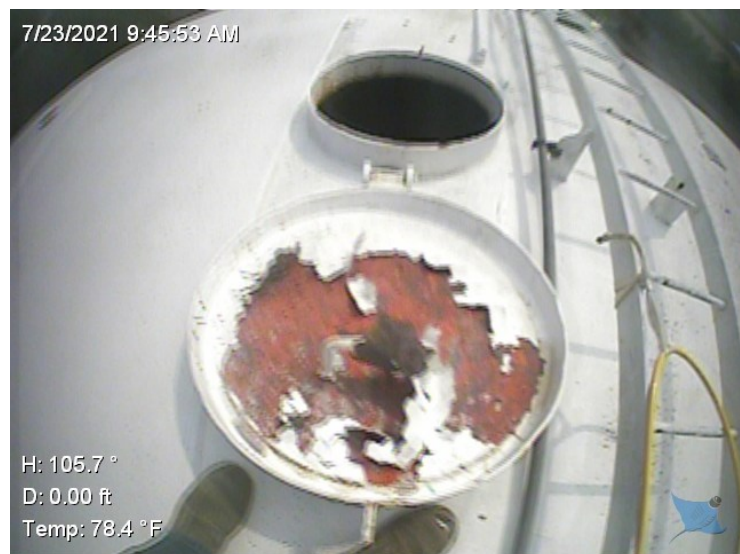
50) The wet interior roof hatch is in good condition. There are spot coating failures on the cover.

13. Replace the wet interior roof hatch with a 30 inch diameter hatch. The estimated cost is \$4,000.
14. Install a handhold at the wet interior roof hatch. The handhold would assist the climber while entering and exiting the opening. The cost would be incidental to the next painting project.

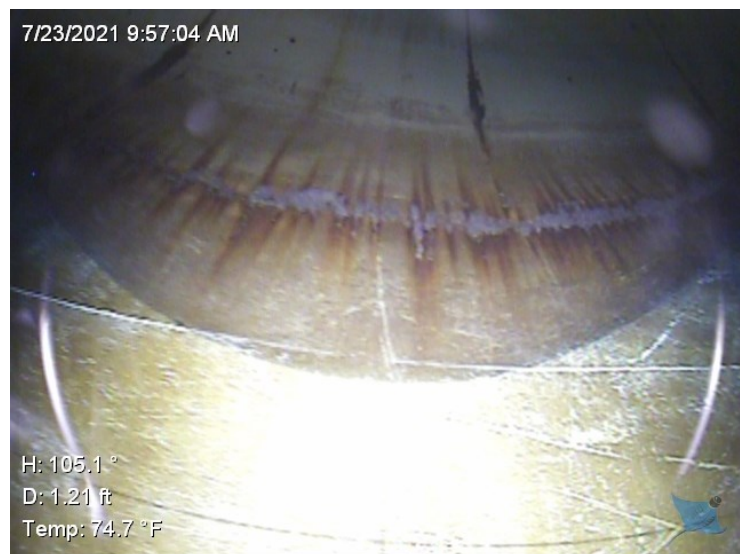
55) Spot coating failures on the wet interior sidewall.

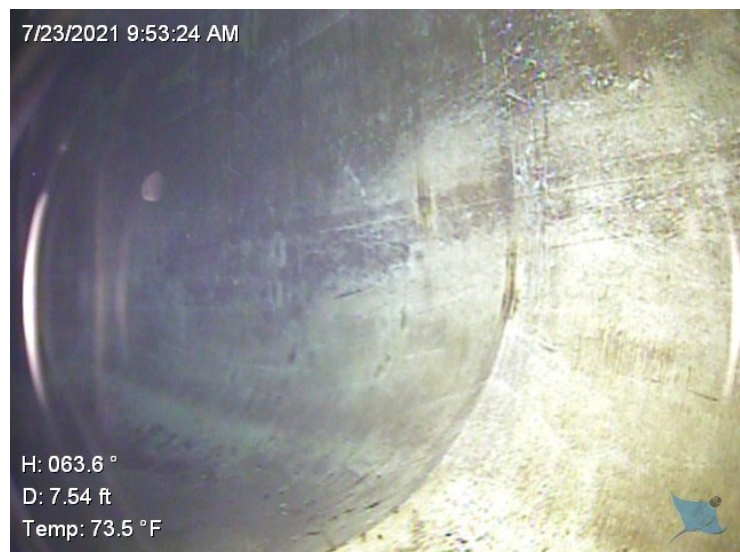
58) Spot coating failures on the sidewall below the water line.

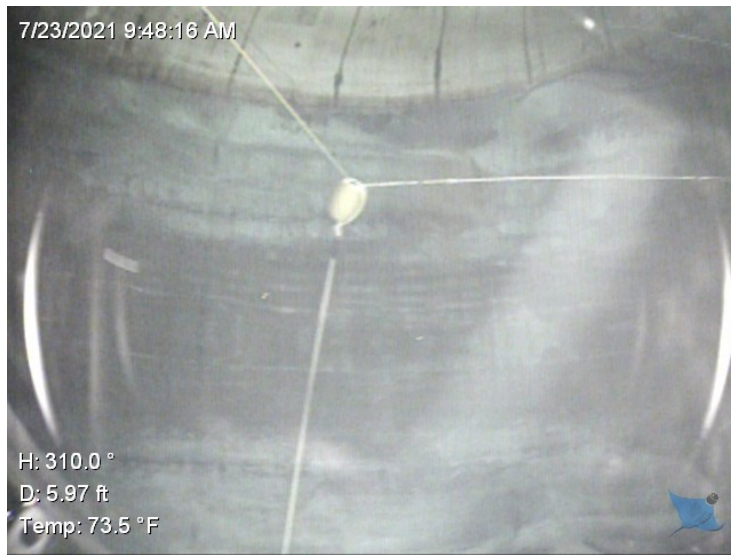
60) The floating ring cathodic protection system appears to be in good condition.
