CITY OF NAPERVILLE

**BID NUMBER: REQ-22-114 WORK
ORDER #4**

**ENGINEERING SERVICES FOR
CENTRAL ELEVATED WATER
TANK RELOCATION**

APPENDIX B – CENTRAL ELEVATED WATER TANK INSPECTION REPORT 10

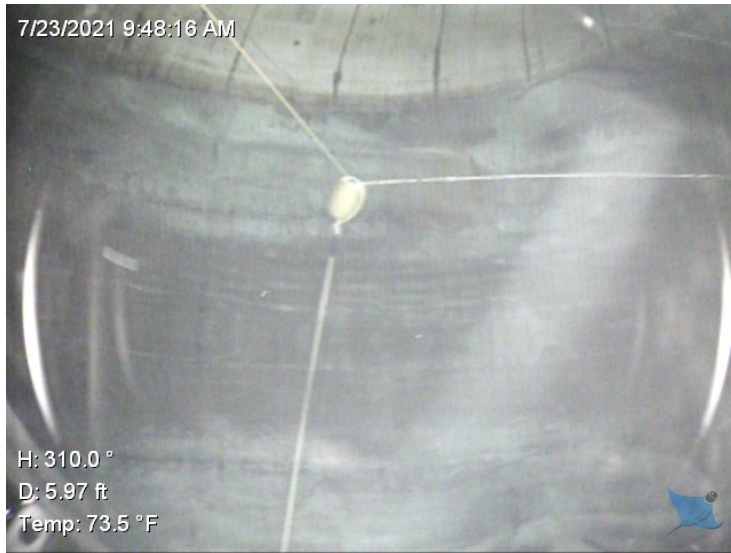
60) The floating ring cathodic protection system appears to be in good condition.

61) Same.

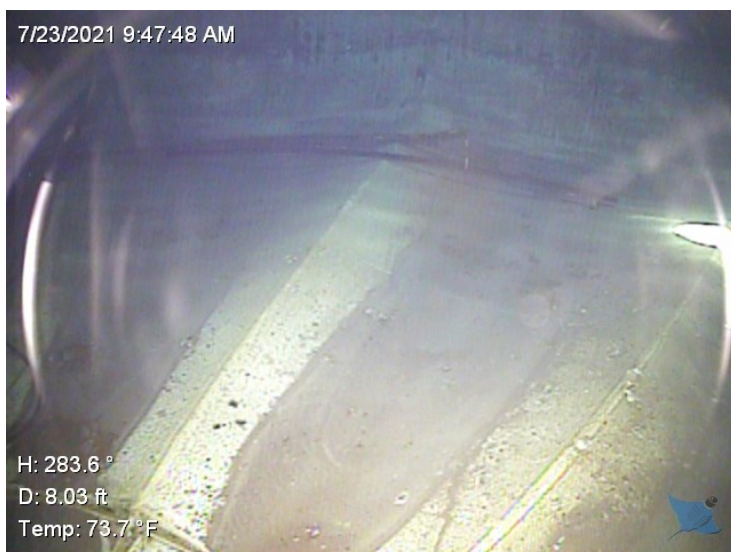
62) The bowl coating is in fair condition overall.

63) Same.
