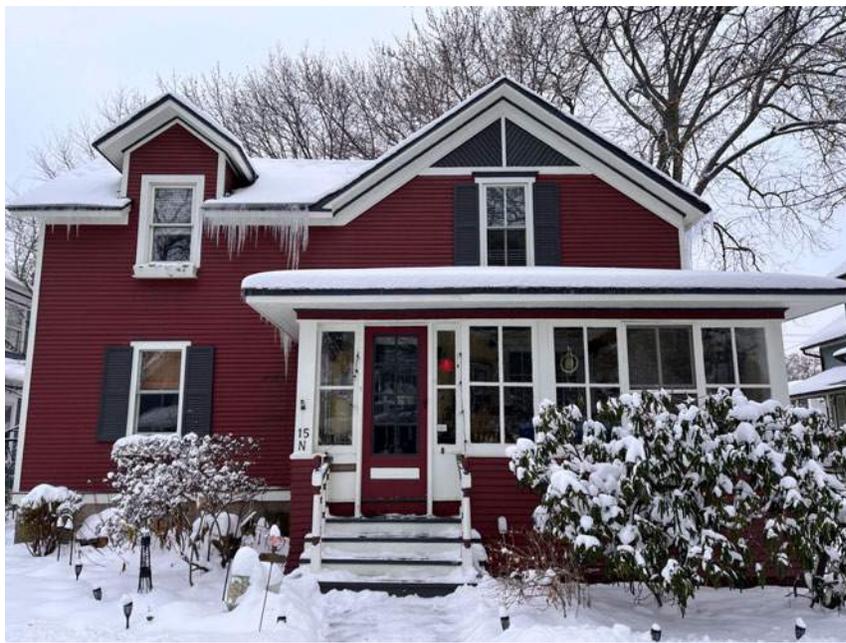
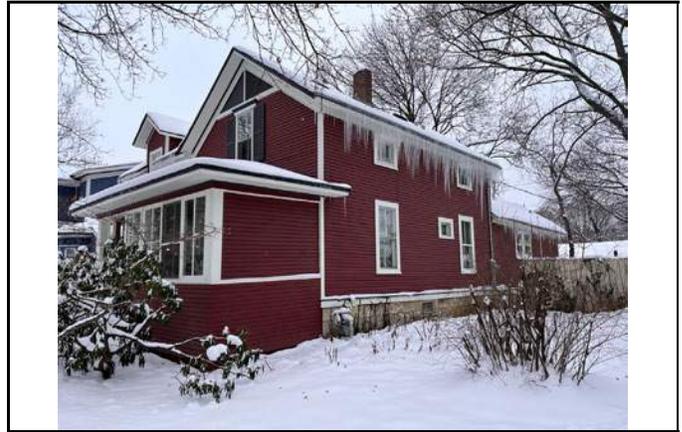
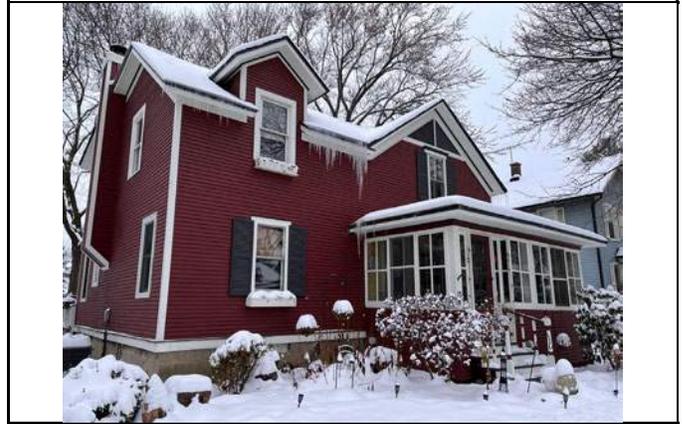
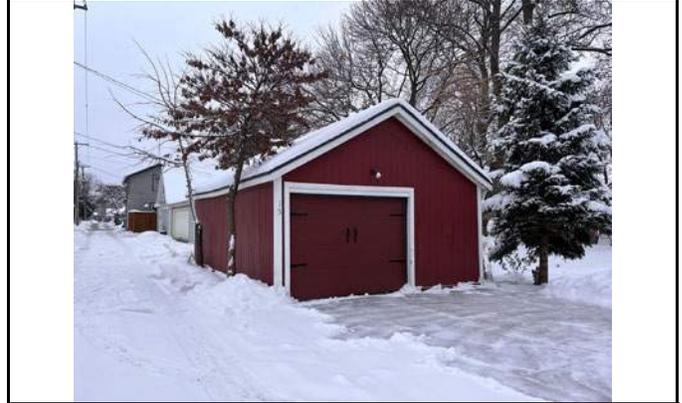
COA COMPLIANCE NOTES: Addition appears to have not been constructed.

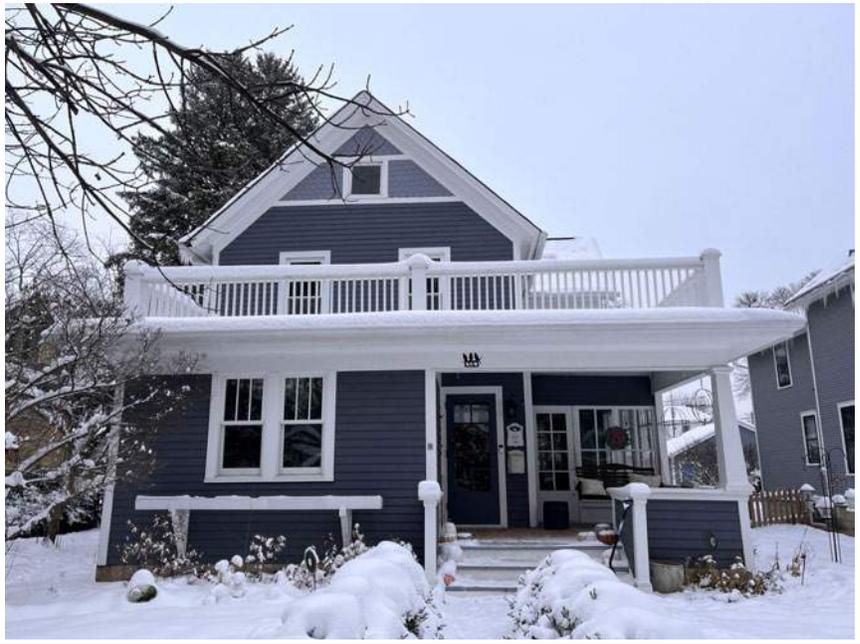
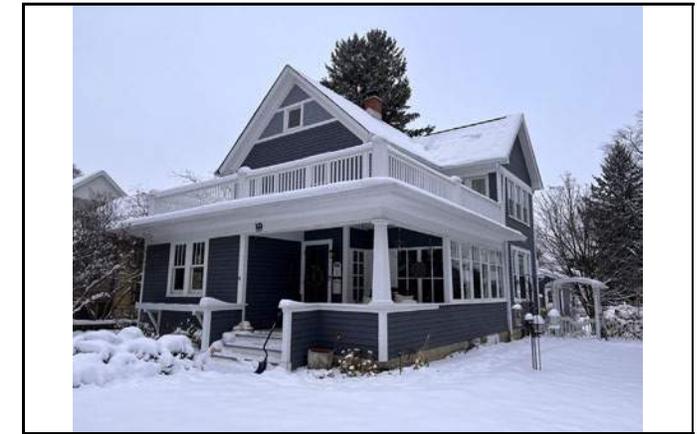
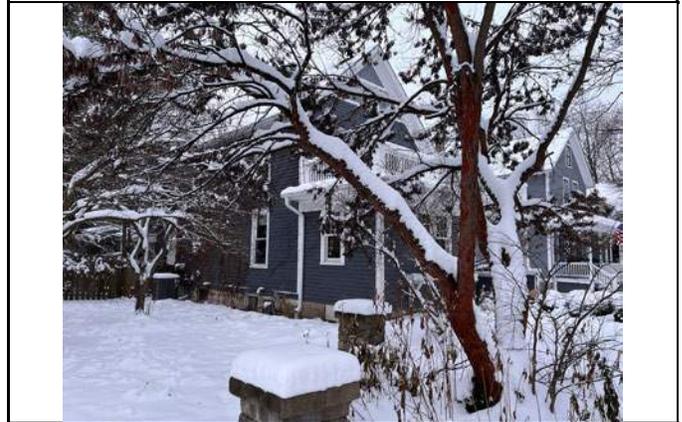
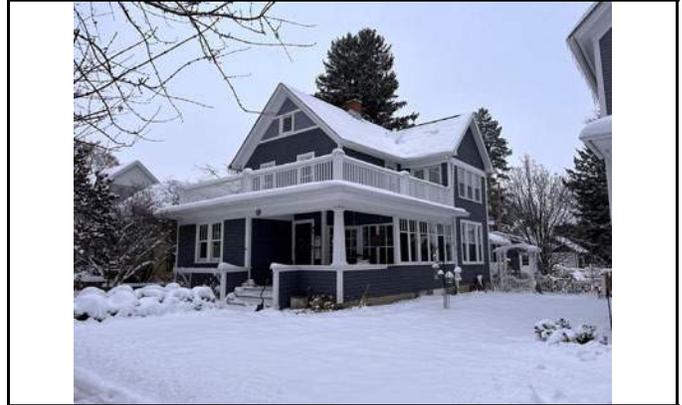
ALTERATIONS 1/1 and 3/1 aluminum/vinyl replacement windows in original openings; 1 story rear addition; rear screen porch addition. Post-2007 -- no changes (exterior repainted)

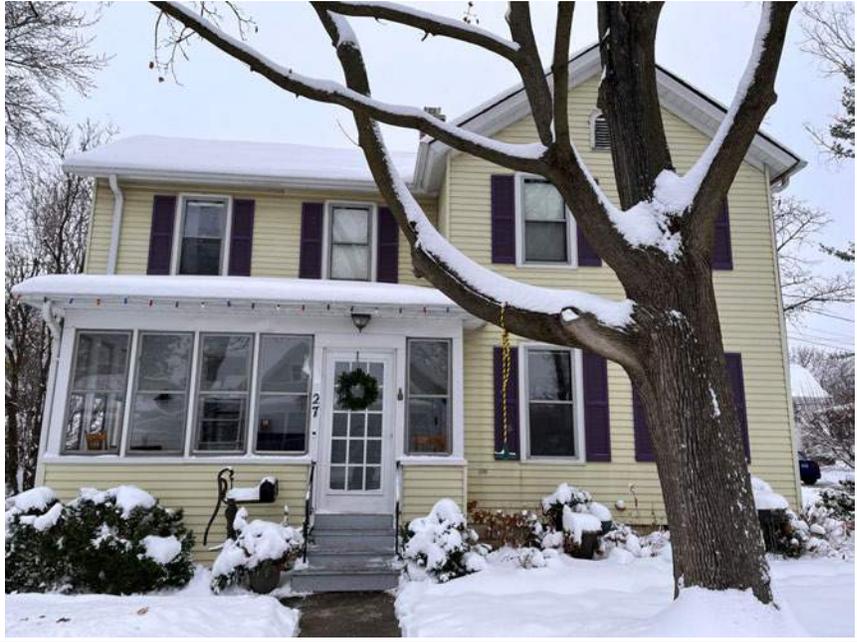
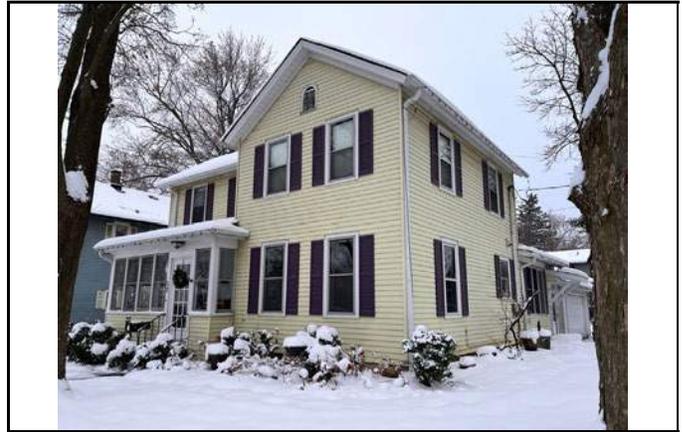
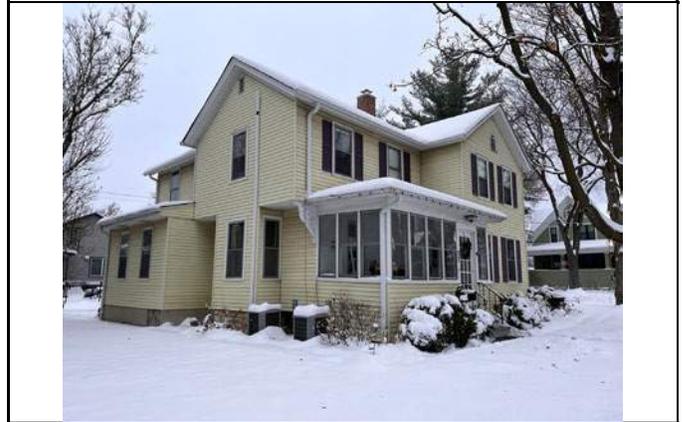
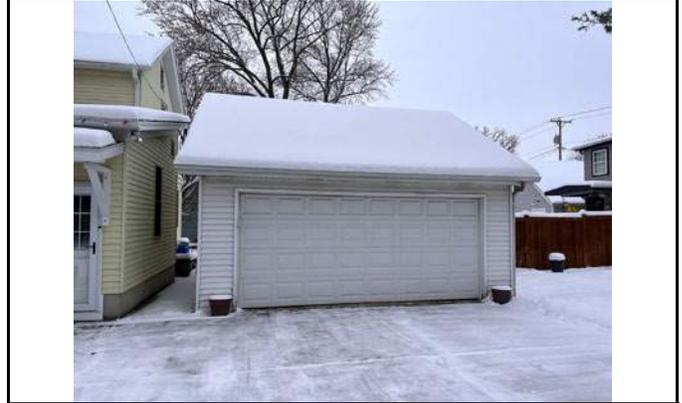
ALTERATIONS Front porch enclosed (post-1954); Aluminum siding (not historic); fixed shutters (not historic); 2nd-story rear addition (c. 1910-15); 1 story rear additions (south and north--post-1954). Post-2007 -- replacement storm door to enclosed front porch.

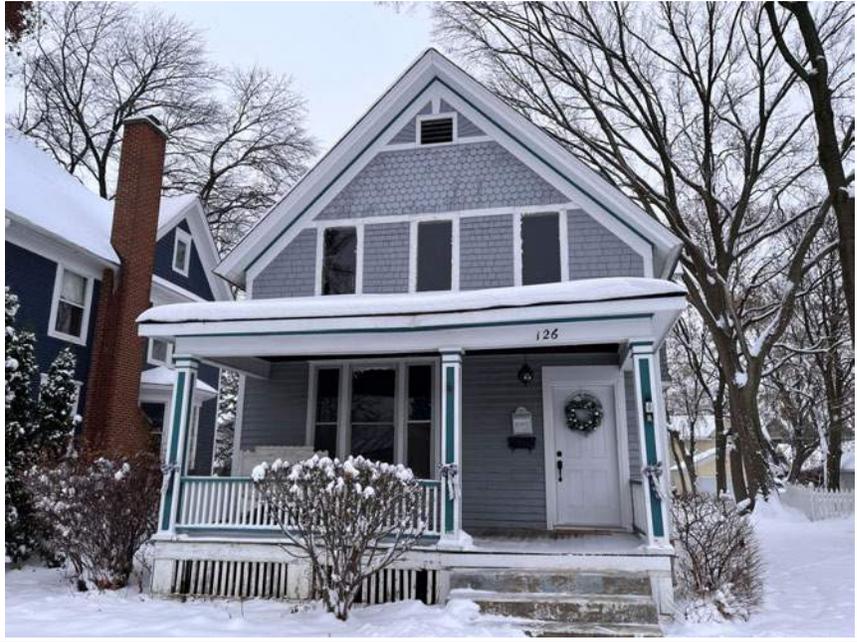
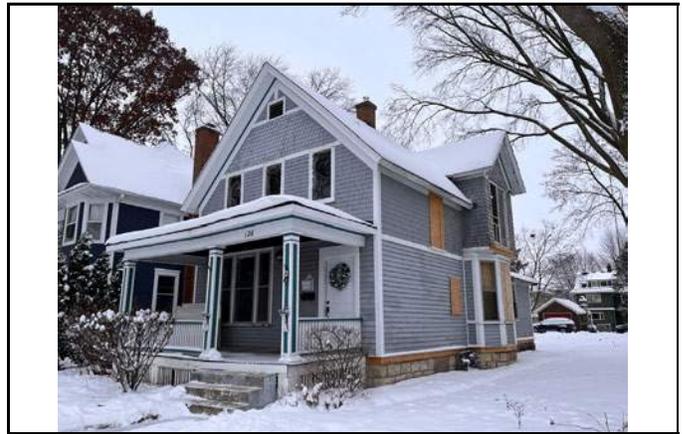
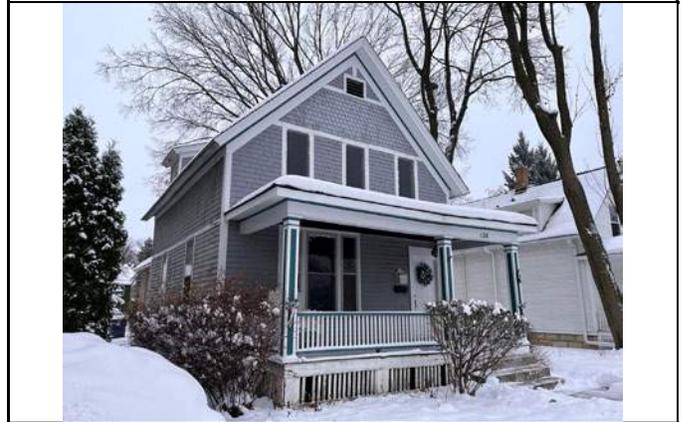
COA COMPLIANCE NOTES: At time of field work, work on rear/south porch addition had not started. Replacement front door does not match door shown on drawings included with COA application -- my be an earlier replacement door that was installed between 2007 survey and COA app.

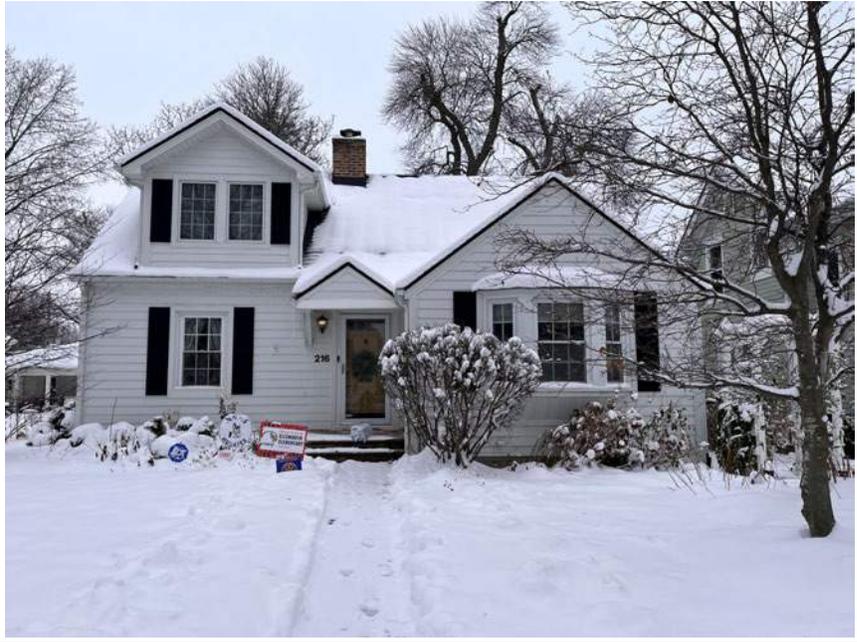
NOTES ON WORK: replacement siding; 6/6 and 4/4 double-hung vinyl replacement windows throughout; replacement entry steps; shed-roof entry canopy replaced with gabled canopy; south entry porch enclosed

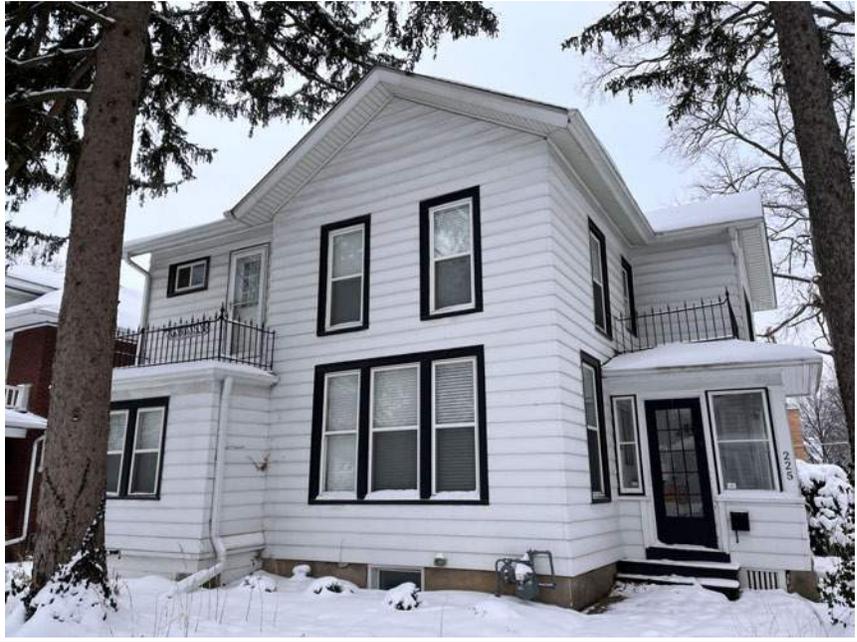
NOTES ON WORK: 1/1 double-hung Aluminum replacement windows throughout.

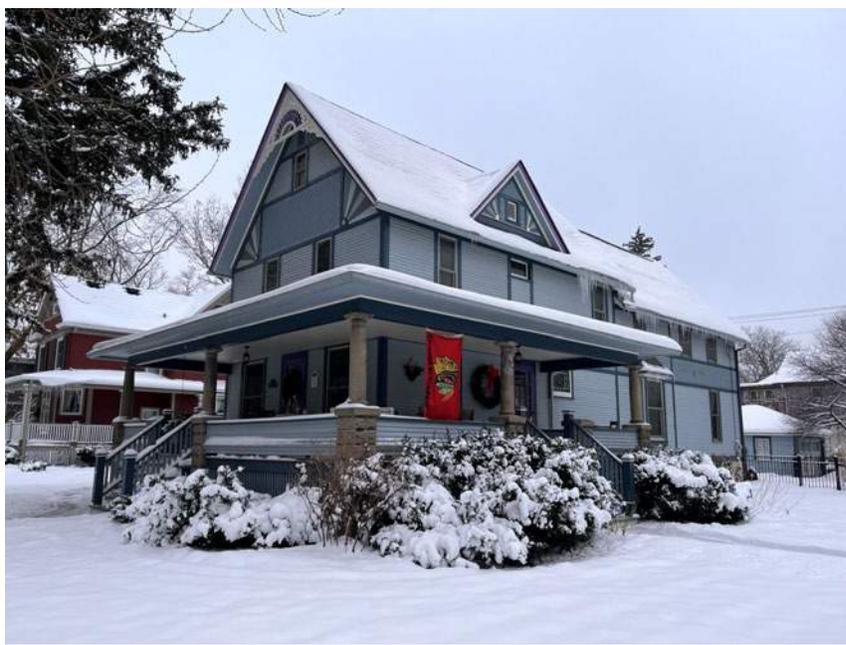
NOTES ON WORK: Most 1/1 windows appear to be Aluminum/vinyl replacement windows. Railings added to front porch steps.

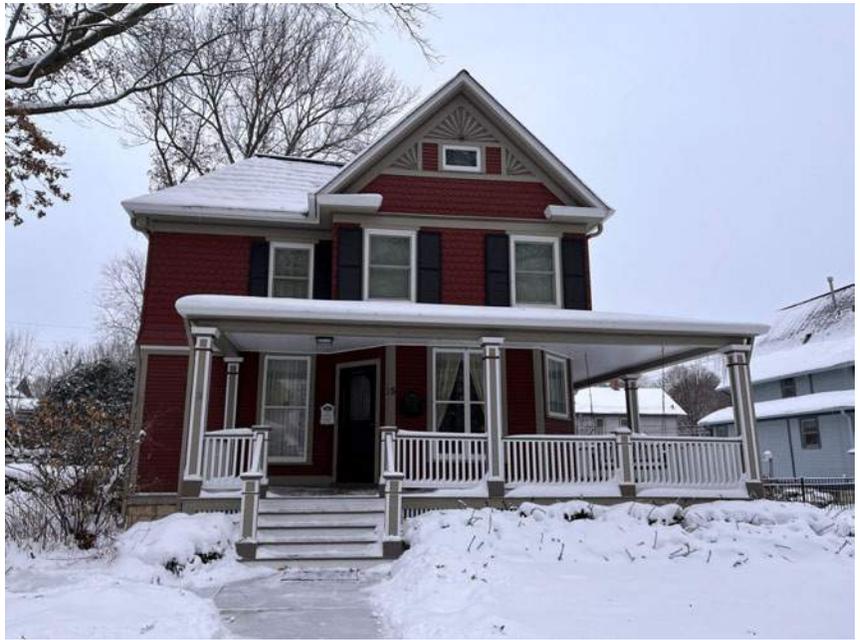
NOTES ON WORK: 1/1 replacement windows on second story of front façade and upper floors of north bay.

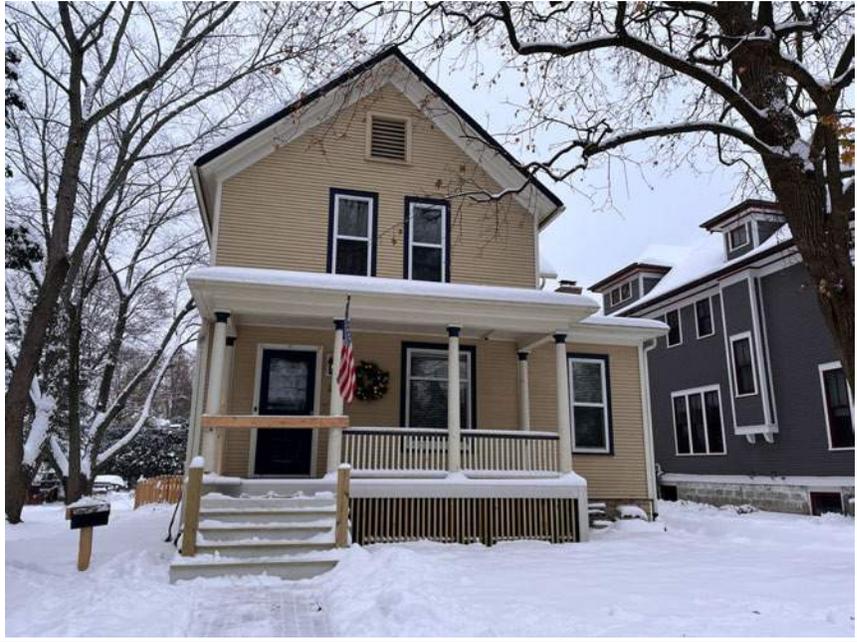
NOTES ON WORK: Porch steps being replaced.

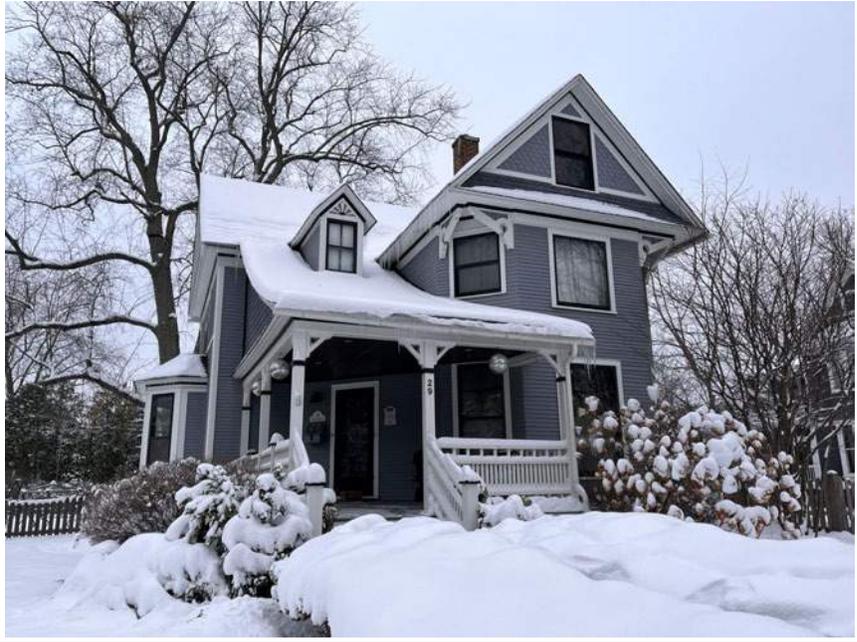
NOTES ON WORK: replacement windows under front and side gables appear to be in enlarged openings
